AFFDL-TR-78-79

REPAIR OF BONDED PRIMARY STRUCTURE

BOEING COMMERCIAL AIRPLANE COMPANY
P.O. BOX 3707
SEATTLE, WASHINGTON 98124

June 1978

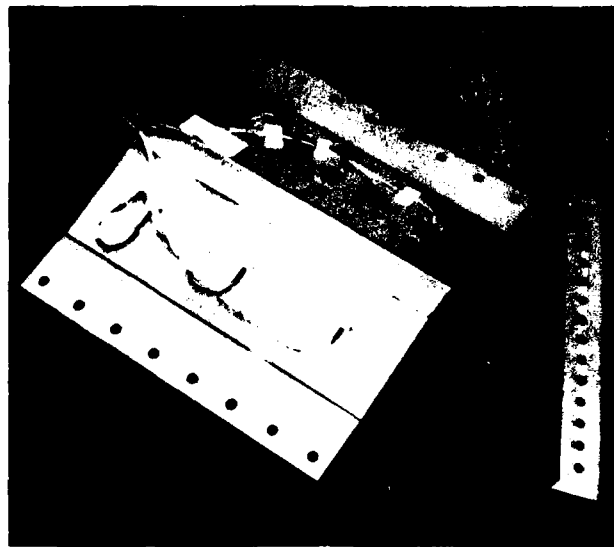
Figure 29.—Typical Failure of Frame Tee Tension Pull-off Panels

A typical failure of the frame tee pull-off panels is shown in Figure 29. Failure was in the bond with the control specimens giving slightly higher results. The test, as seen previously in Figure 26, induced very high peel loads at the edge of the tee leg. Delamination started earlier in the repaired panel where splice doublers were bonded on the legs. This was because of the greater stiffness of the laminate build-up as compared to the initial tapered leg. A suggested solution is to extend the first splice strap to locally stiffen the skin and thus soften the load transition at that point. This can be seen in Figure 30.

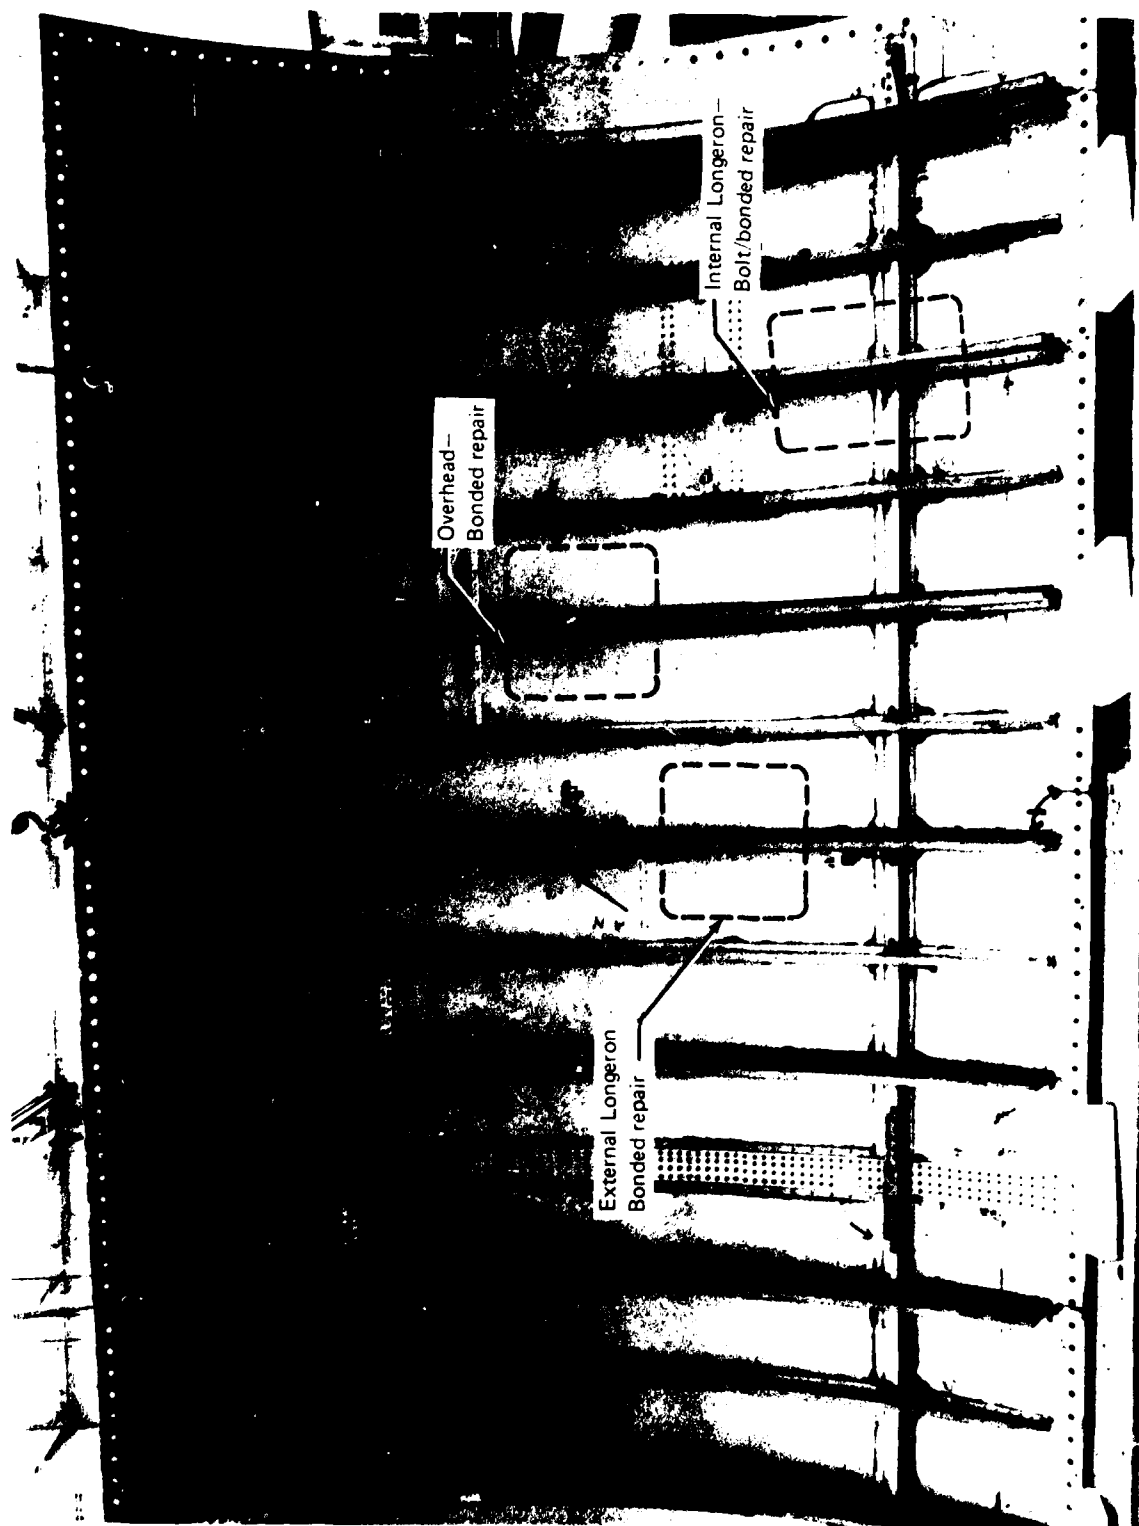
Figure 48. —Location of Repair Demonstration Areas—Pabst Panel

During coordination with Douglas, a large PABST pressure test panel (110 in. x 168 in.) was identified on which testing had been completed and which could be surplused to this program. The panel, shown in Figure 48, had been used for damage tolerance testing and had several temporary repairs that had been made to permit test continuity. Adequate areas remained, however, where permanent repairs of a structural type could be demonstrated.

Three areas where repairs could be accomplished were selected. These are shown in Figure 48. The first area was at the intersection of an internal longeron and frame. Pressure for bonding, in this case, was obtained by using mechanical fasteners.

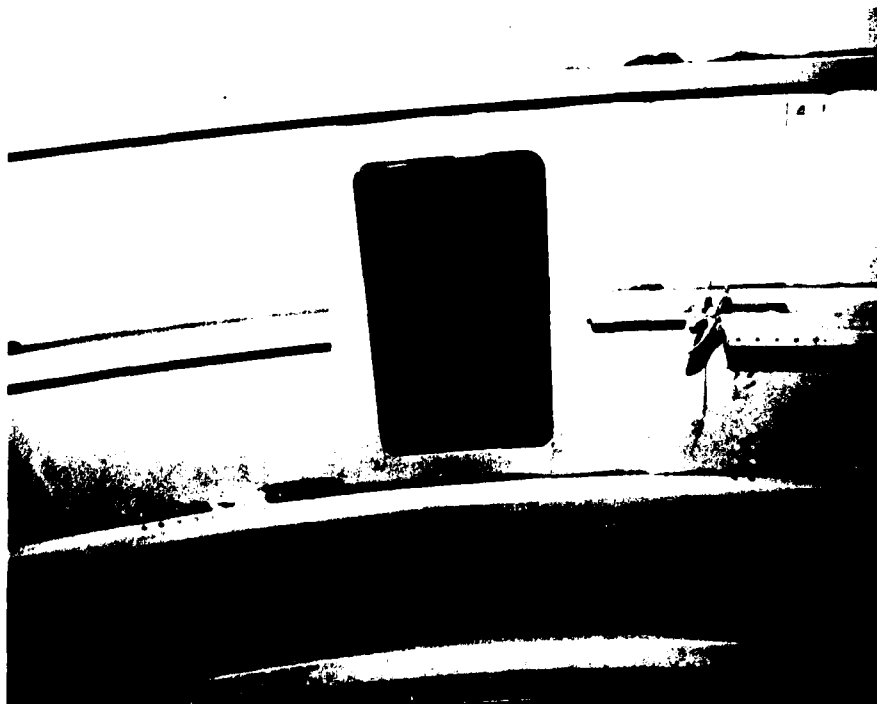
Figure 76.—Material Removed for Overhead Repair

The primary purpose of the third repair was to demonstrate the feasibility of using the phosphoric acid hand anodizing procedure in the overhead mode. The panel is shown mounted in the overhead position in Figure 75. The repair included a section of the skin and frame tee. The removed material is shown in Figure 76. After removal of the metal, the organic coating was removed from the bond areas and peripheral masking applied.
